# VULCRAFT/VERCO GROUP ACOUSTICAL PERFORMANCE TEST REPORT

ASTM E90 AND ASTM E492 TESTING ON FOREST RX RUBBER BACK SHEET VINYL

Vulcraft 20 Gage Dove Tail 2.00 Steel Deck

H7786.04-113-11-R1

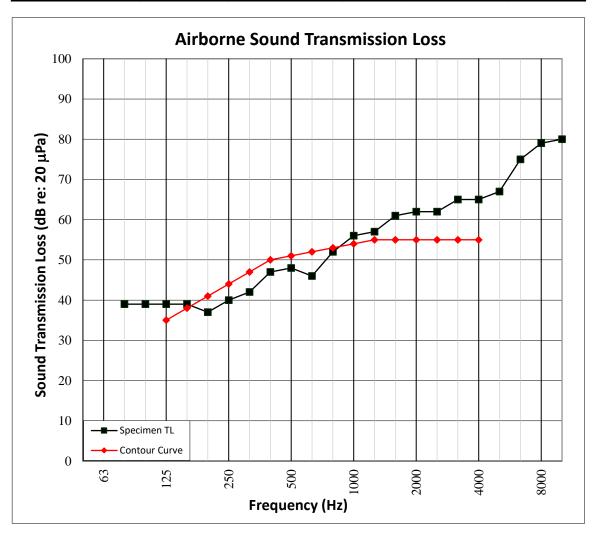
# **TEST RESULTS - AIRBORNE SOUND TRANSMISSION LOSS GRAPH**

| TEST DATE DATA FILE NO. CLIENT | | /ulcraft/Verco Group | | | |
|---|---|--|---|---|---|
| DESCRIPTION | | est Rx Rubber Back Shee<br>ge Vulcraft Dove Tail 2.0 | • • | 7 mm Standard 4000 | PSI Concrete, |
| SPECIMEN AREA | 10.98 m² | Receive Temp. | 19.1°C | Source Temp. | 18.3°C |

| FREQ | BACKGROUND | ABSORPTION | SOURCE | RECEIVE | SPECIMEN | 95% | NUMBER |
|---|---|---|---|---|---|---|---|
| STC Ratin | 51 | (Sound Transmi | ssion Class) | | Sum o | f Deficiencies | 26 |

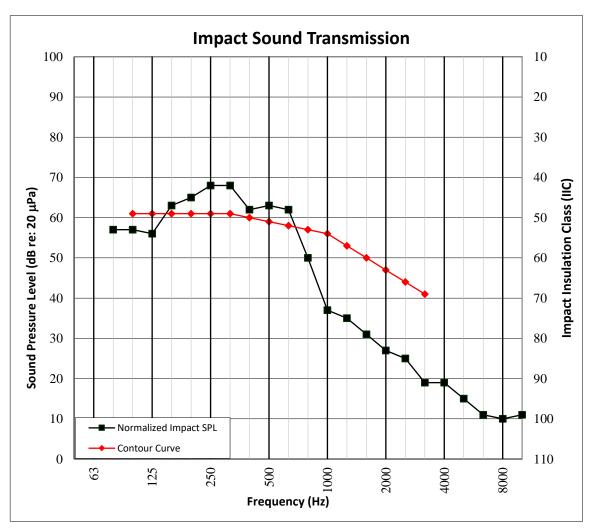
# **TEST RESULTS - IMPACT SOUND TRANSMISSION GRAPH**

| TEST DATE | 2/10/2018 | 2/10/2018 | | | | |
|---|---|--|---|---|---|--|
| DESCRIPTION | | est Rx Rubber Back Shee<br>ge Vulcraft Dove Tail 2.0 | - | 7 mm Standard 4000 | PSI Concrete, | |
| SPECIMEN AREA | 10.98 m² | Maximum Temp. | 20.6°C | Minimum Temp. | 18.1°C | |

| FREQ | BACKGROUND<br>SPL | ABSORPTION | NORMALIZED IMPACT SP | 95%<br>CONFIDENCE | NUMBER<br>OF |
|---|---|---|---|---|---|
| <b>IIC Rati</b> | ng 51 | (Impact Insula | tion Class) | Sum of Deficienci | es 30 |

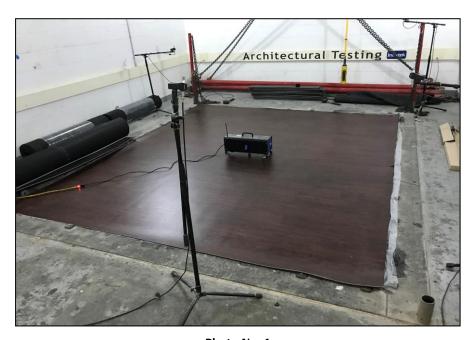
Photo No. 1
Source Room View of Test Specimen Installation

The full test specimen was assembled on the day of testing by B&C. All materials provided by the client were installed on an existing B&C assembly (Vulcraft 20 Gage Dove Tail 2.00 Steel Deck) utilizing B&C-supplied materials. The assembly was installed in a steel test frame which was installed into the opening between the source and receive rooms in the test chamber. The test frame was isolated from the structure with dense neoprene gasket.

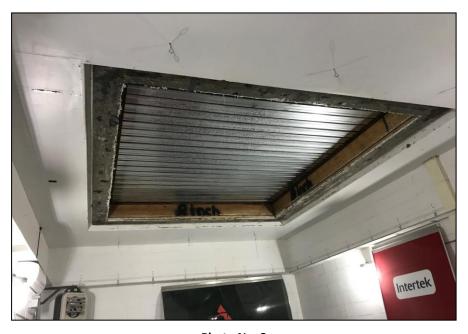
Photo No. 2
Receive Room View of Test Specimen Installation

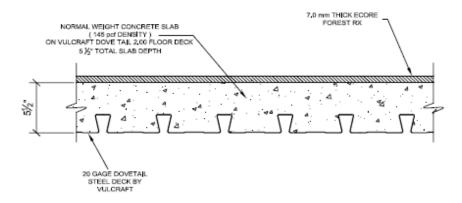
**Drawing of Test Specimen (supplied by Client)**

| MATERIAL | DIMENSIONS<br>(mm/inch) | THICKNESS<br>(mm/inch) | MANUFACTURER AND SERIES | QUANTITY | AVERAGE<br>WEIGHT | | |
|---|--|---|---|---|---|--|--|
| Rubber Back<br>Sheet Vinyl | Note: A sheet of 2 mil polyethylene plastic was adhered to the floor slab with 3M Super 77 spray adhesive. The floor topping was adhered to the sheeting with ECORE™ EGrip™ III adhesive, which was spread using a 0.79 mm by 1.59 mm by 0.79 mm trowel. Adhesive was allowed to cure per manufacturer's specifications. | | | | | | |
| PSI Concrete | Note: Poured directly on the floor deck and allowed to cure for a minimum of 28 days. | | | | | | |
| Steel Deck Note: Installed per manufacturer's specifications in a test frame with the top of the with the source room. All seams and gaps underneath the deck were plugged with sealed with Pecora AC-20 Acoustical Sealant. | | | | | | | |
