ACOUSTICAL PERFORMANCE TEST REPORT

ASTM E90 AND ASTM E492 TESTING ON
ATTAIN LVT OVER 5 MM ECOSILENCE UNDERLAYMENT

Vulcraft 20 Gage Dove Tail 3.50 Steel Deck

H7787.03-113-11-R0

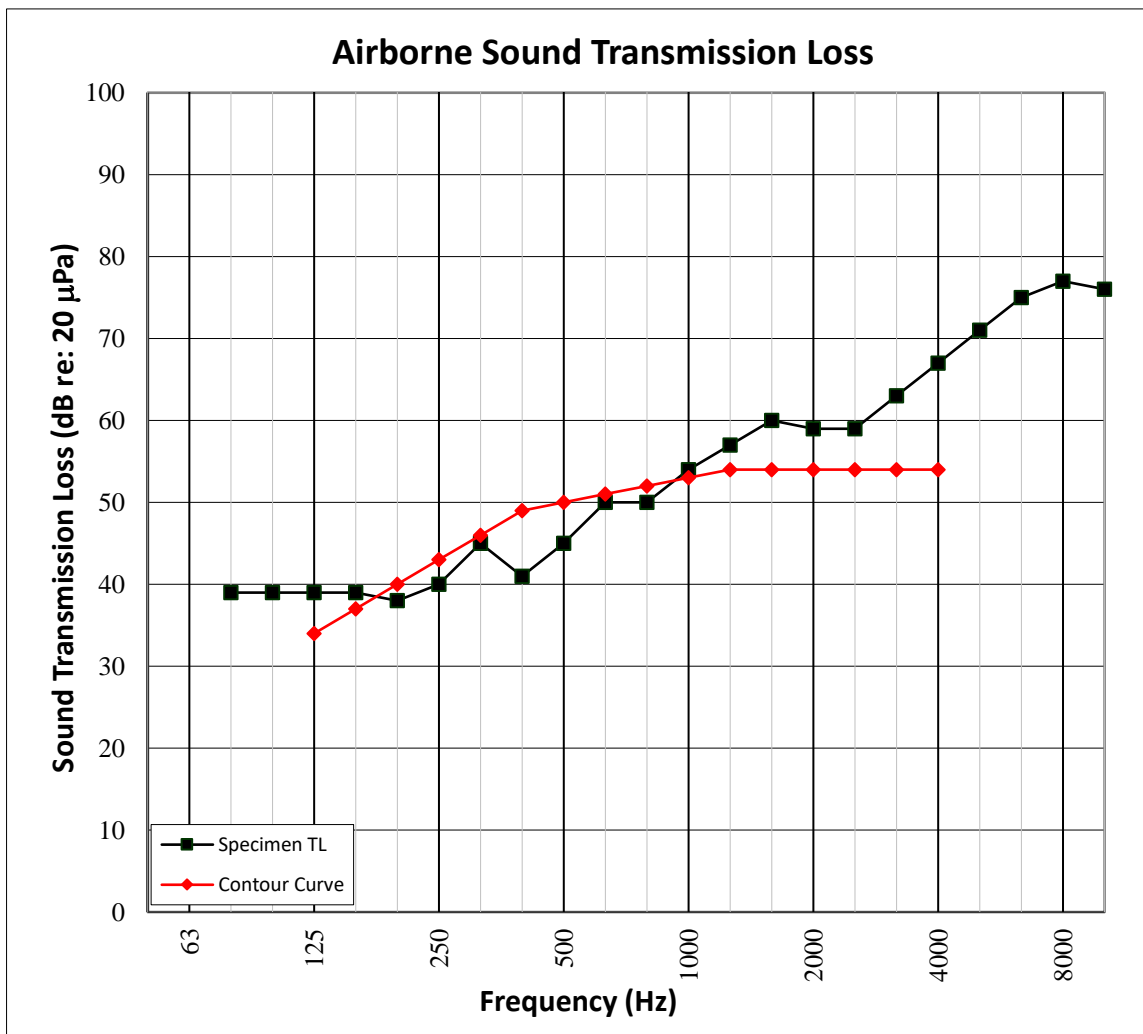
TEST RESULTS - AIRBORNE SOUND TRANSMISSION LOSS GRAPH

TEST DATE	2/18/2018				
DATA FILE NO.	H7787.03				
CLIENT	Vulcraft/Verco Group				
DESCRIPTION	2.5 mm ECORE Attain Luxury Vinyl Tile, 5 mm ECOSilence Rubber Underlayment, 152.4 mm Standard 4000 PSI Concrete, 152.4 mm 20 Gage Vulcraft Dove Tail 3.50 Steel Deck				
SPECIMEN AREA	10.98 m ²	Receive Temp.	19.2°C	Source Temp.	19.4°C
TECHNICIAN	JPT	Receive Humidity	50%	Source Humidity	50%

FREQ (Hz)	BACKGROUND SPL (dB)	ABSORPTION m ²	SOURCE SPL (dB)	RECEIVE SPL (dB)	SPECIMEN TL (dB)	95% CONFIDENCE LIMIT	NUMBER OF DEFICIENCIES
80	30.4	16.5	110	69	39	3.5	-
100	29.5	13.5	105	65	39	2.6	-
125	28.8	10.4	104	65	39	1.3	0
160	24.4	10.1	108	69	39	1.0	0
200	21.3	9.6	105	68	38	1.5	2
250	29.9	11.4	104	64	40	1.0	3
315	20.1	10.0	106	61	45	0.8	1
400	20.5	9.5	105	65	41	0.8	8
500	23.3	8.2	104	60	45	0.6	5
630	18.3	7.9	105	56	50	0.4	1
800	17.8	7.6	104	55	50	0.4	2
1000	15.1	7.4	104	52	54	0.3	0
1250	12.0	7.3	104	48	57	0.3	0
1600	11.3	7.5	104	46	60	0.6	0
2000	9.8	8.5	104	45	59	0.3	0
2500	8.8	9.1	102	44	59	0.4	0
3150	8.2	10.2	103	40	63	0.4	0
4000	8.6	11.9	104	37	67	0.3	0
5000	9.1	13.9	104	32	71	0.5	-
6300	9.8	17.9	98	20	75	0.5	-
8000	10.6	23.9	97	17	77	0.6	-
10000	11.5	30.6	93	12	76	0.7	-
STC Rating	50	<i>(Sound Transmission Class)</i>			Sum of Deficiencies	22

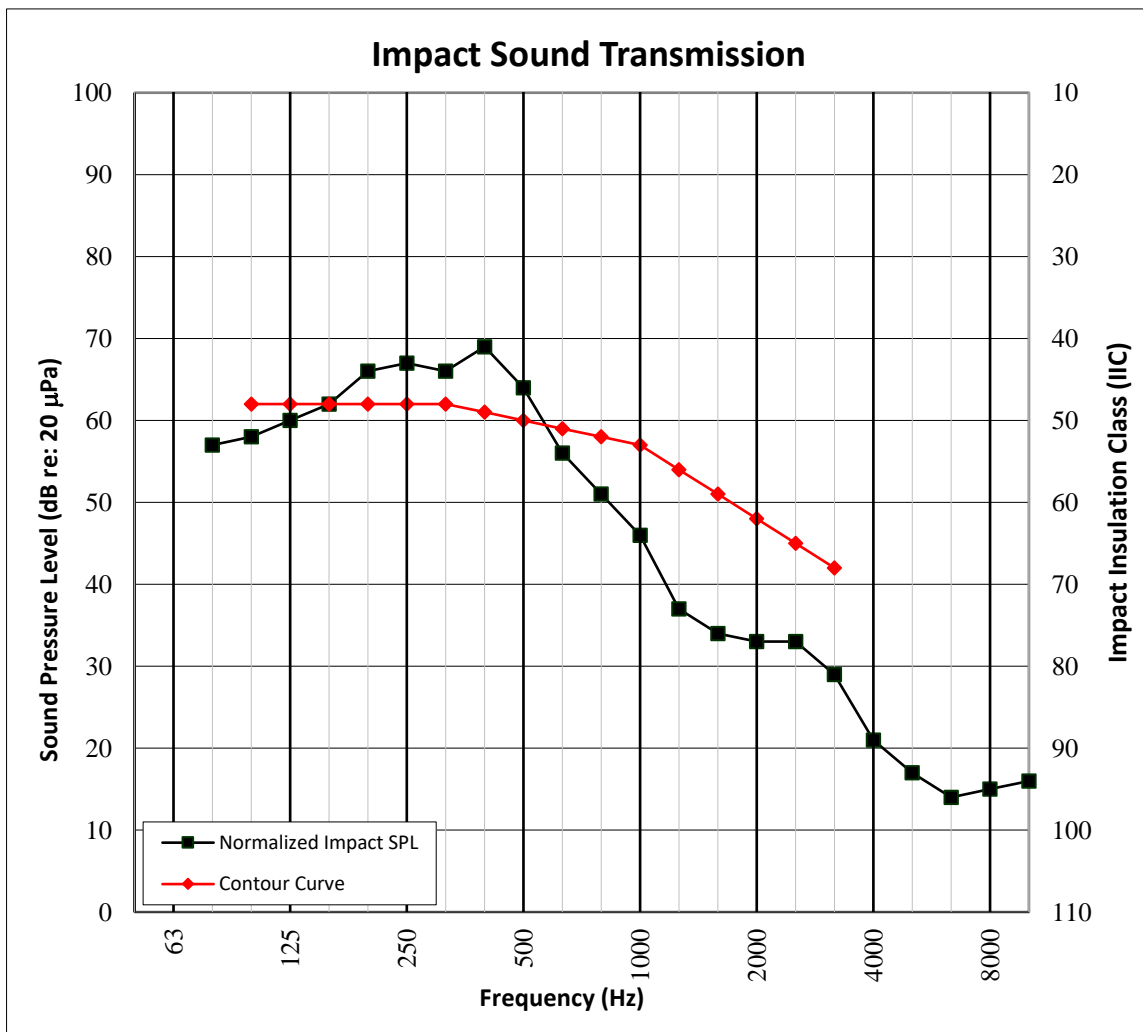
TEST RESULTS - IMPACT SOUND TRANSMISSION GRAPH

TEST DATE	2/18/2018				
DATA FILE NO.	H7787.03				
CLIENT	Vulcraft/Verco Group				
DESCRIPTION	2.5 mm E CORE Attain Luxury Vinyl Tile, 5 mm ECOsilence Rubber Underlayment, 152.4 mm Standard 4000 PSI Concrete, 152.4 mm 20 Gage Vulcraft Dove Tail 3.50 Steel Deck				
SPECIMEN AREA	10.98 m ²	Maximum Temp.	19.5°C	Minimum Temp.	18.9°C
TECHNICIAN	JPT	Max. Humidity	51%	Min. Humidity	49%

FREQ (Hz)	BACKGROUND SPL (dB)	ABSORPTION m ²	NORMALIZED IMPACT SPL (dB)	95% CONFIDENCE LIMIT	NUMBER OF DEFICIENCIES
80	32.5	16.7	57	1.7	-
100	28.1	14.6	58	1.0	0
125	30.8	10.5	60	1.6	0
160	23.4	10.3	62	0.6	0
200	20.3	10.1	66	0.8	4
250	29.7	10.6	67	0.7	5
315	19.8	9.9	66	0.5	4
400	20.2	9.5	69	0.5	8
500	22.9	8.1	64	0.3	4
630	17.1	8.0	56	0.6	0
800	15.3	7.7	51	0.3	0
1000	14.0	7.4	46	0.3	0
1250	11.5	7.3	37	0.3	0
1600	11.1	7.4	34	0.4	0
2000	9.9	8.4	33	0.3	0
2500	8.9	9.1	33	0.3	0
3150	8.3	10.2	29	0.3	0
4000	8.7	11.9	21	0.6	-
5000	9.1	13.8	17	0.6	-
6300	9.8	17.8	14	0.4	-
8000	10.6	23.9	15	0.4	-
10000	11.5	30.5	16	0.5	-
IIC Rating	50	<i>(Impact Insulation Class)</i>		Sum of Deficiencies	25

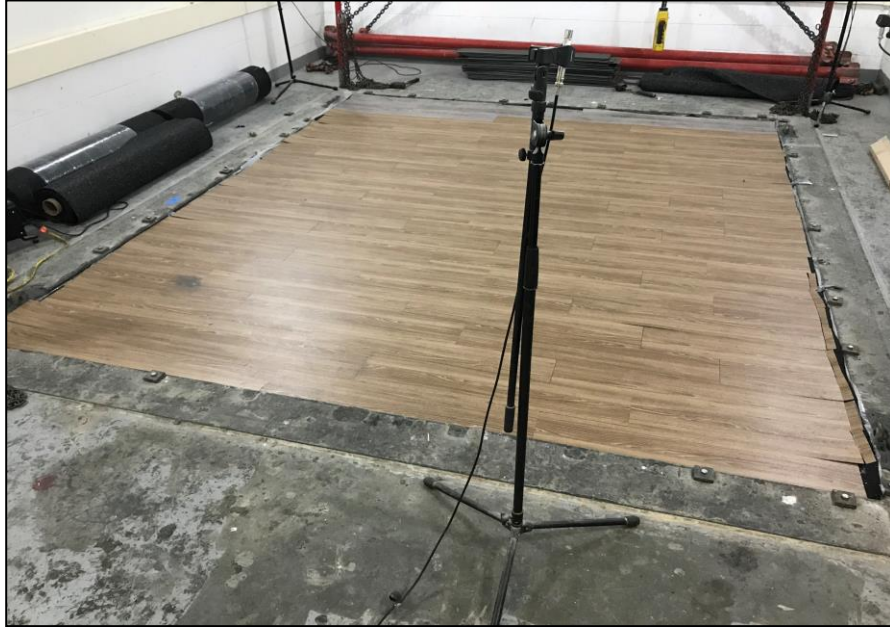
Photo No. 1

Source Room View of Test Specimen Installation

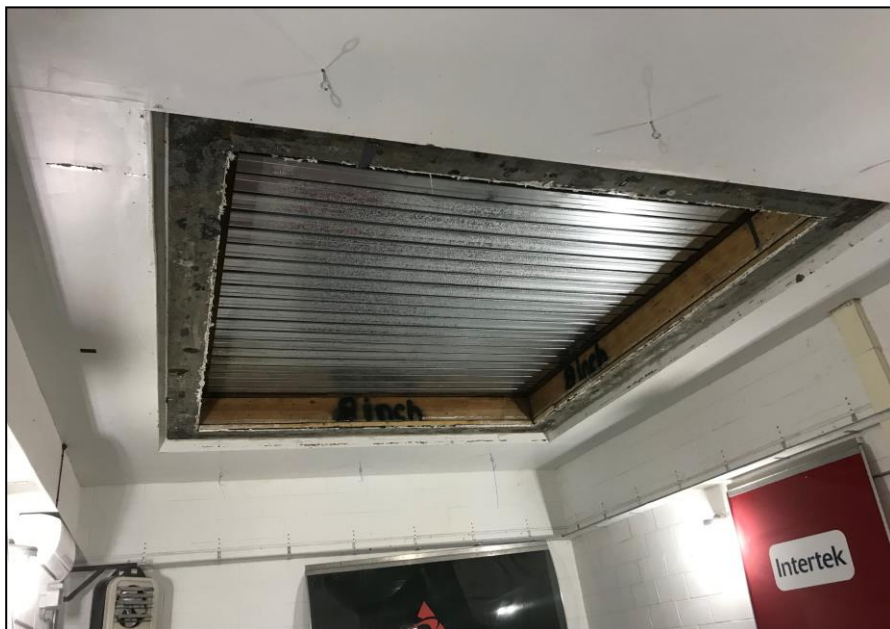
Photo No. 2

Receive Room View of Test Specimen Installation

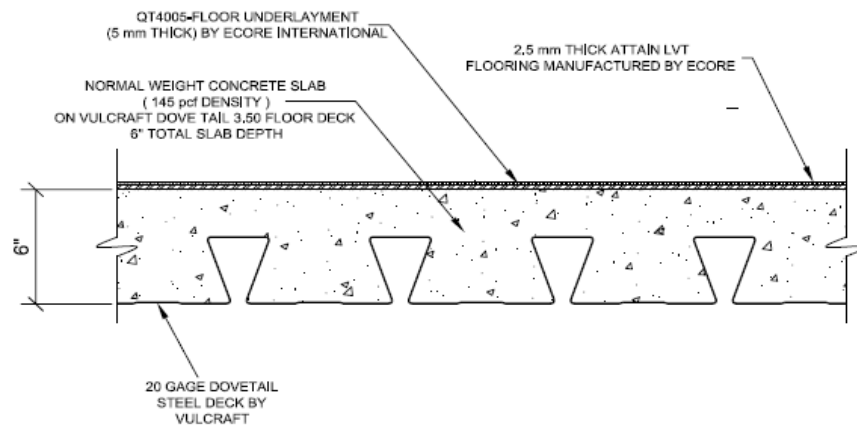
Drawing of Test Specimen (supplied by Client)

MATERIAL	DIMENSIONS (mm/inch)	THICKNESS (mm/inch)	MANUFACTURER AND SERIES	QUANTITY	AVERAGE WEIGHT
Luxury Vinyl Tile	914.4 by 152.4	2.5	ECORE Attain	10.98 m ²	3.37 kg/m ²
	Note: Adhered to the underlayment with ECORE™ EGrip™ III adhesive using a 0.79 mm by 1.59 mm by 0.79 mm trowel. Adhesive was allowed to cure per manufacturer's specifications.				
Rubber Underlayment	3023 by 1219	5.0	ECOsilence	10.98 m ²	4.2 kg/m ²
	Note: A sheet of 2 mil polyethylene plastic was adhered to the floor slab with 3M Super 77 spray adhesive. The underlayment was adhered to the sheeting with ECORE™ EGrip™ III adhesive, which was spread using a 0.79 mm by 1.59 mm by 0.79 mm trowel. Adhesive was allowed to cure per manufacturer's specifications.				
Standard 4000 PSI Concrete	3023 by 3632	152.4	N/A	10.98 m ²	270.63 kg/m ²
	Note: Poured directly on the floor deck and allowed to cure for a minimum of 28 days.				
Steel Deck	3023 by 609.6	152.4	20 Gage Vulcraft Dove Tail 3.50	10.98 m ²	12.01 kg/m ²

Note: Installed per manufacturer's specifications in a test frame with the top of the concrete flush with the source room. All seams and gaps underneath the deck were plugged with backer rod and sealed with Pecora AC-20 Acoustical Sealant.
