VULCRAFT/VERCO GROUP ACOUSTICAL PERFORMANCE TEST REPORT

ASTM E90 AND ASTM E492 TESTING ON
CERAMIC TILE OVER 5 MM ECOSILENCE UNDERLAYMENT

Vulcraft 20 Gage Dove Tail 3.50 Steel Deck with Wire-Hung Gypsum Board Ceiling

I5133.02-113-11-R0

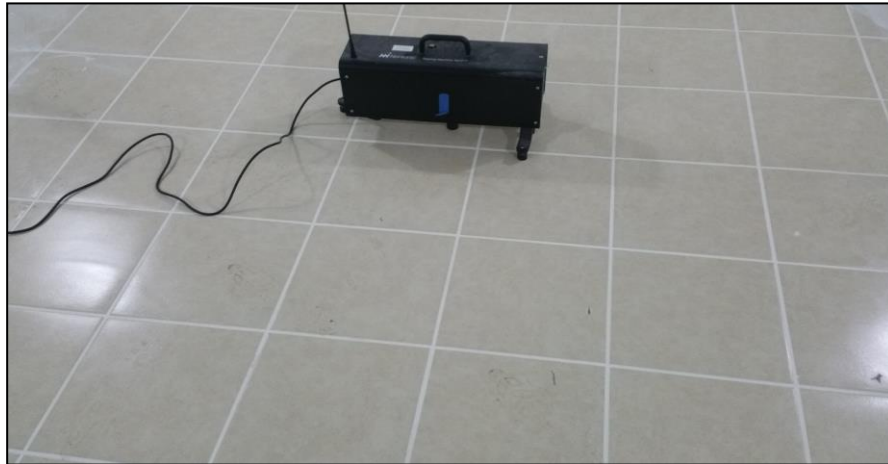
Photo No. 1
Close-Up of Test Specimen

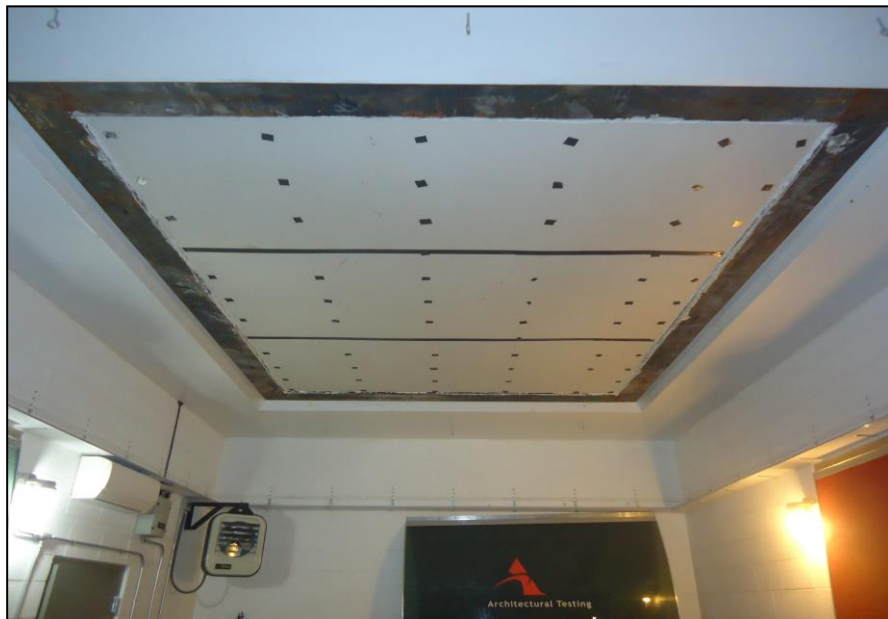
Photo No. 2
Receive Room View of Test Specimen Installation
