## ACOUSTICAL PERFORMANCE TEST REPORT

ASTM E90 AND ASTM E492 TESTING ON  
CERAMIC TILE OVER 5 MM ECOSILENCE UNDERLAYMENT

Vulcraft 20 Gage Dove Tail 2.00 Steel Deck

H7786.06-113-11-R2

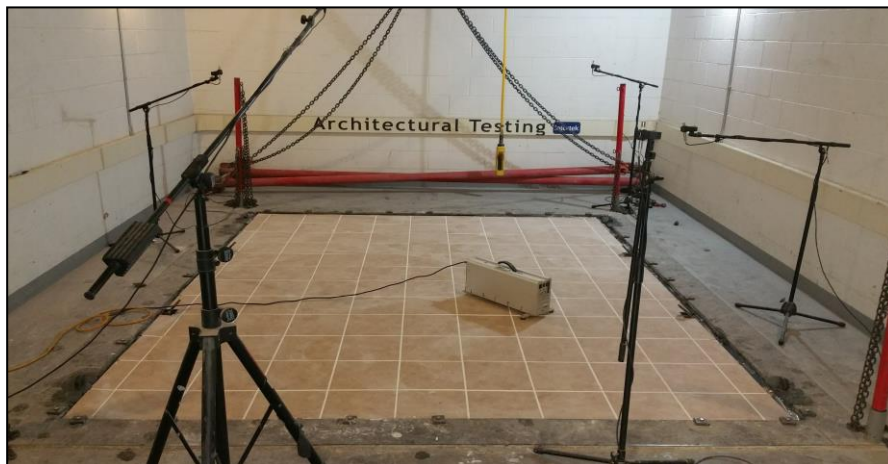
**Photo No. 1****Source Room View of Test Specimen Installation**

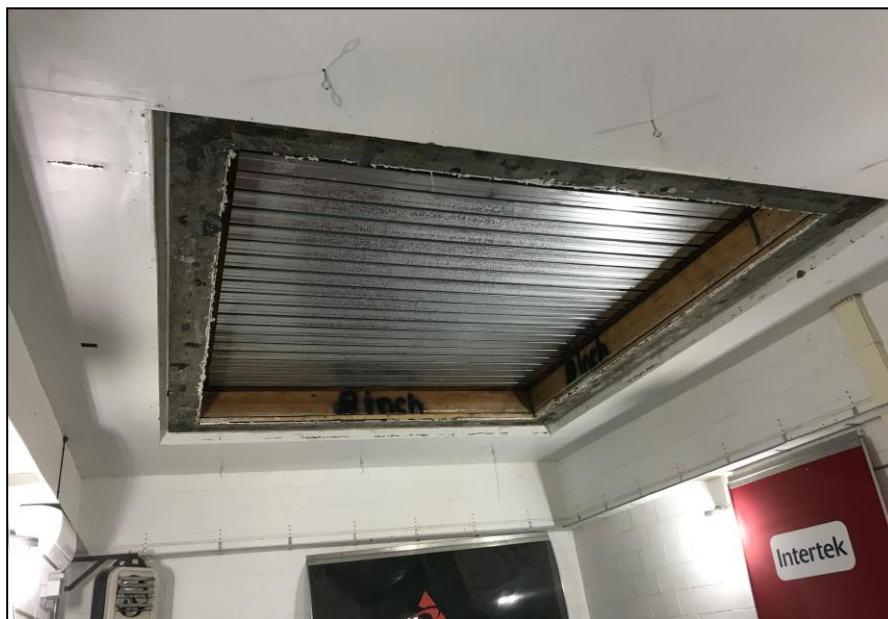
**Photo No. 2****Receive Room View of Test Specimen Installation**
