VULCRAFT/VERCO GROUP ACOUSTICAL PERFORMANCE TEST REPORT

ASTM E90 AND ASTM E492 TESTING ON FOREST RX RUBBER BACK SHEET VINYL

Vulcraft 20 Gage Dove Tail 2.00 Steel Deck with Gypsum Board Ceiling

H7786.10-113-11-R1

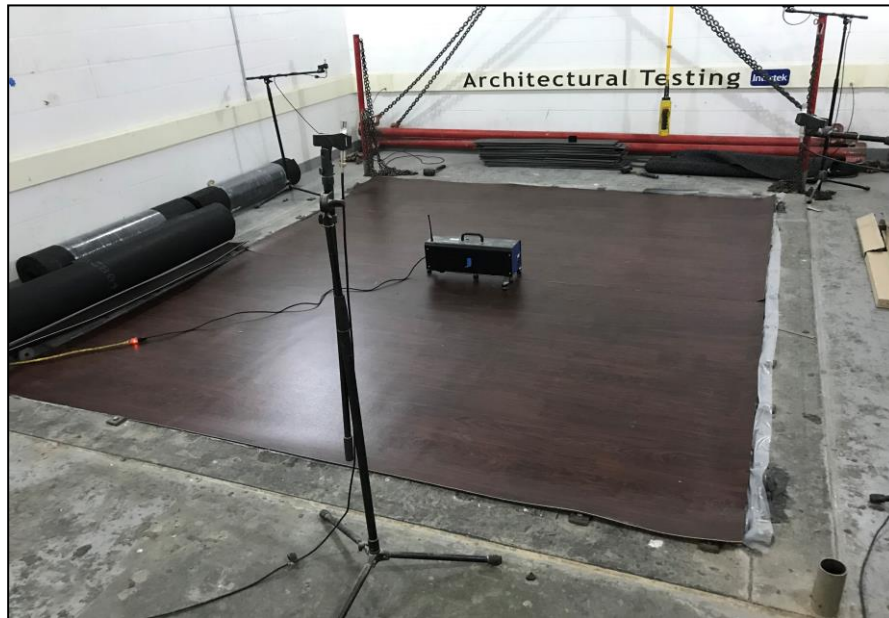
Photo No. 1

Source Room View of Test Specimen Installation

The full test specimen was assembled on the day of testing by B&C. All materials provided by the client were installed on an existing B&C assembly (Vulcraft 20 Gage Dove Tail 2.00 Steel Deck with Gypsum Board Ceiling) utilizing B&C-supplied materials. The assembly was installed in a steel test frame which was installed into the opening between the source and receive rooms in the test chamber. The test frame was isolated from the structure with dense neoprene gasket.

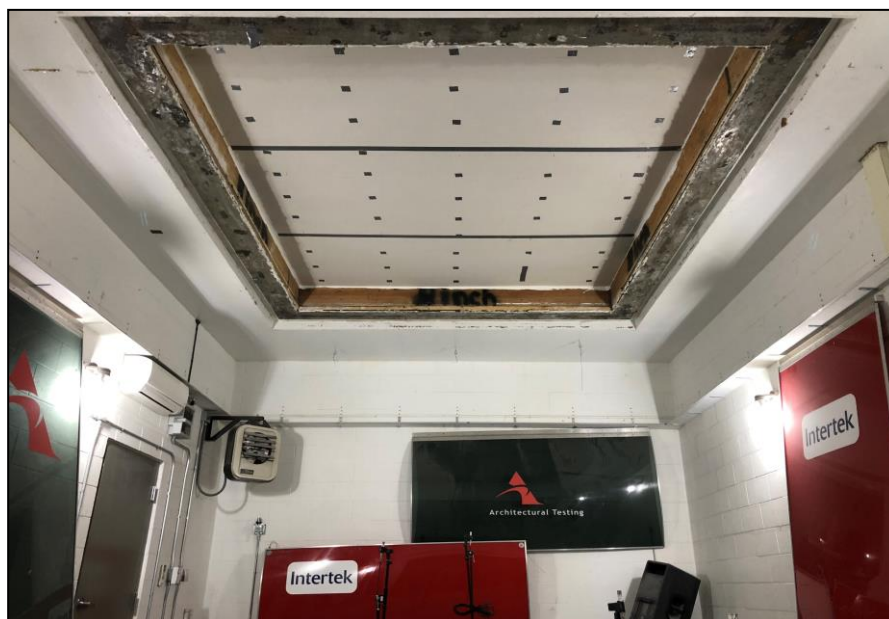
Photo No. 2

Receive Room View of Test Specimen Installation
