ACOUSTICAL PERFORMANCE TEST REPORT

ASTM E90 AND ASTM E492 TESTING ON
CERAMIC TILE OVER 5 MM ECOSILENCE UNDERLAYMENT

Vulcraft 20 Gage Dove Tail 2.00 Steel Deck with Gypsum Board Ceiling

H7786.12-113-11-R1

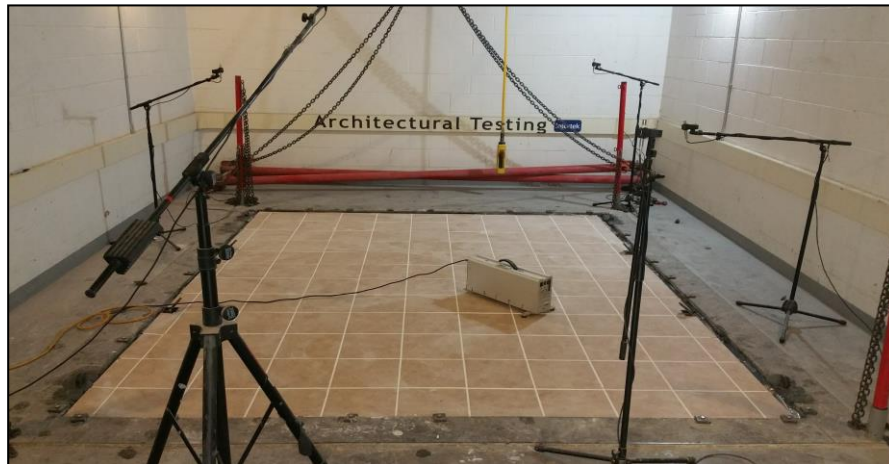
Photo No. 1

Source Room View of Test Specimen Installation

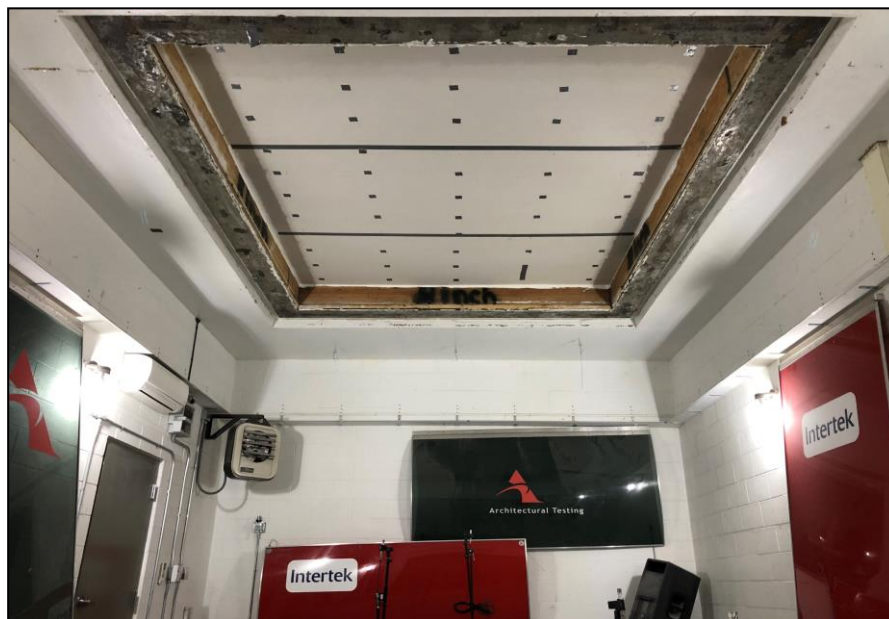
Photo No. 2

Receive Room View of Test Specimen Installation
