ACOUSTICAL PERFORMANCE TEST REPORT

ASTM E90 AND ASTM E492 TESTING ON
FUSION HYBRID OVER 2 MM ECOSILENCE UNDERLAYMENT

Vulcraft 20 Gage Dove Tail 3.50 Steel Deck

H7787.02-113-11-R0

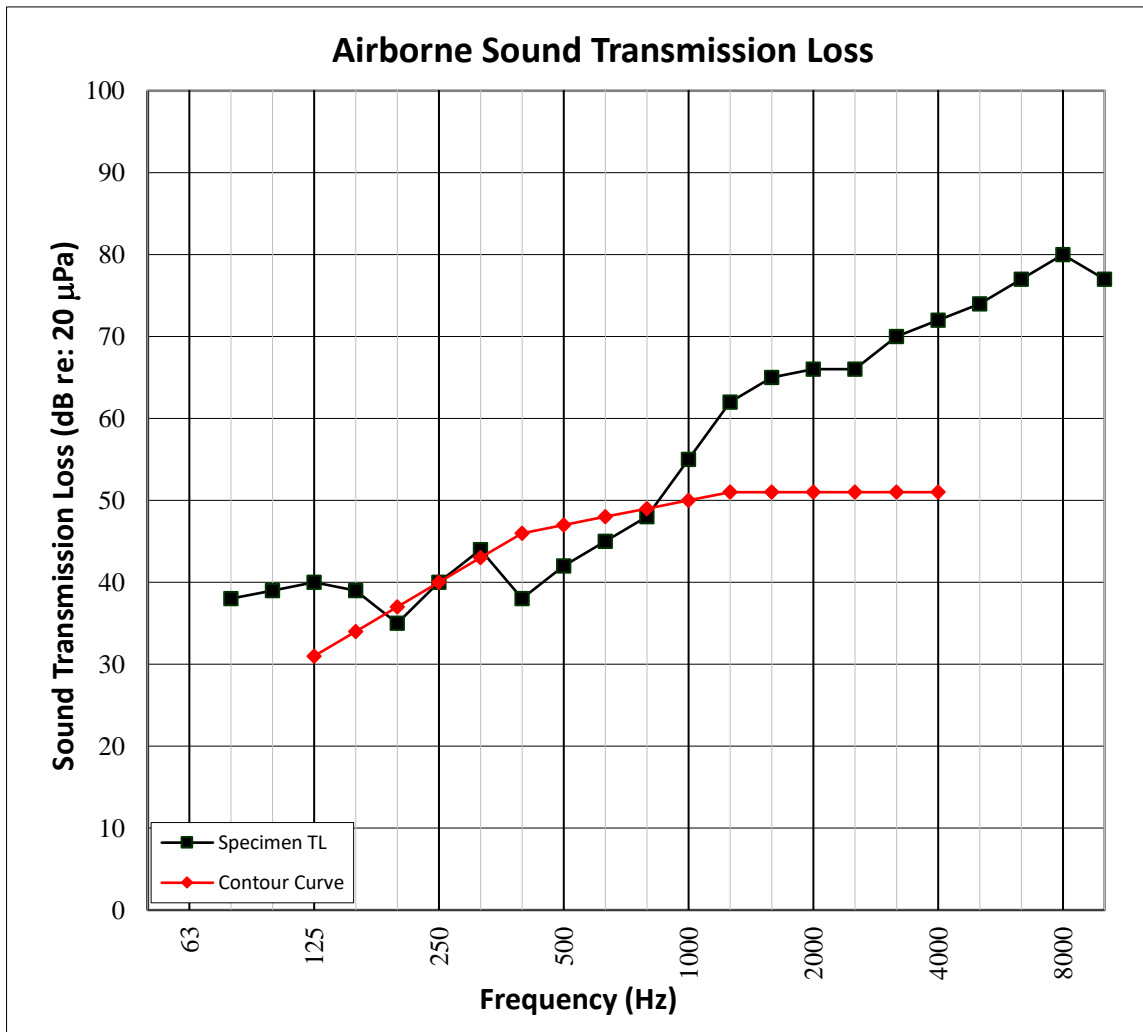
TEST RESULTS - AIRBORNE SOUND TRANSMISSION LOSS GRAPH

TEST DATE	2/18/2018				
DATA FILE NO.	H7787.02				
CLIENT	Vulcraft/Verco Group				
DESCRIPTION	4 mm Derr Flooring Fusion Hybrid Luxury Vinyl Plank, 2 mm ECOsilence Rubber Underlayment, 152.4 mm Standard 4000 PSI Concrete, 152.4 mm 20 Gage Vulcraft Dove Tail 3.50 Steel Deck				
SPECIMEN AREA	10.98 m ²	Receive Temp.	19.2°C	Source Temp.	19.5°C
TECHNICIAN	JPT	Receive Humidity	50%	Source Humidity	50%

FREQ (Hz)	BACKGROUND SPL (dB)	ABSORPTION m ²	SOURCE SPL (dB)	RECEIVE SPL (dB)	SPECIMEN TL (dB)	95% CONFIDENCE LIMIT	NUMBER OF DEFICIENCIES
80	27.6	16.3	109	69	38	3.4	-
100	28.2	14.0	105	65	39	1.8	-
125	26.0	10.2	105	66	40	1.7	0
160	19.8	10.0	107	68	39	1.1	0
200	17.9	10.6	104	69	35	1.8	2
250	29.5	11.1	104	64	40	1.3	0
315	18.7	9.7	105	61	44	0.8	0
400	18.2	9.3	104	67	38	0.9	8
500	25.7	8.1	103	63	42	0.7	5
630	16.1	7.8	104	60	45	0.5	3
800	15.9	7.5	103	56	48	0.4	1
1000	15.5	7.4	104	50	55	0.5	0
1250	11.9	7.2	103	43	62	0.4	0
1600	11.9	7.5	104	40	65	0.4	0
2000	9.7	8.4	103	39	66	0.4	0
2500	7.4	9.2	102	36	66	0.4	0
3150	7.2	10.3	103	33	70	0.4	0
4000	8.0	12.2	104	31	72	0.4	0
5000	8.9	14.3	103	28	74	0.3	-
6300	9.7	18.7	97	18	77	0.6	-
8000	10.6	24.9	97	14	80	0.7	-
10000	11.4	31.4	92	11	77	0.6	-
STC Rating	47	(Sound Transmission Class)			Sum of Deficiencies	19

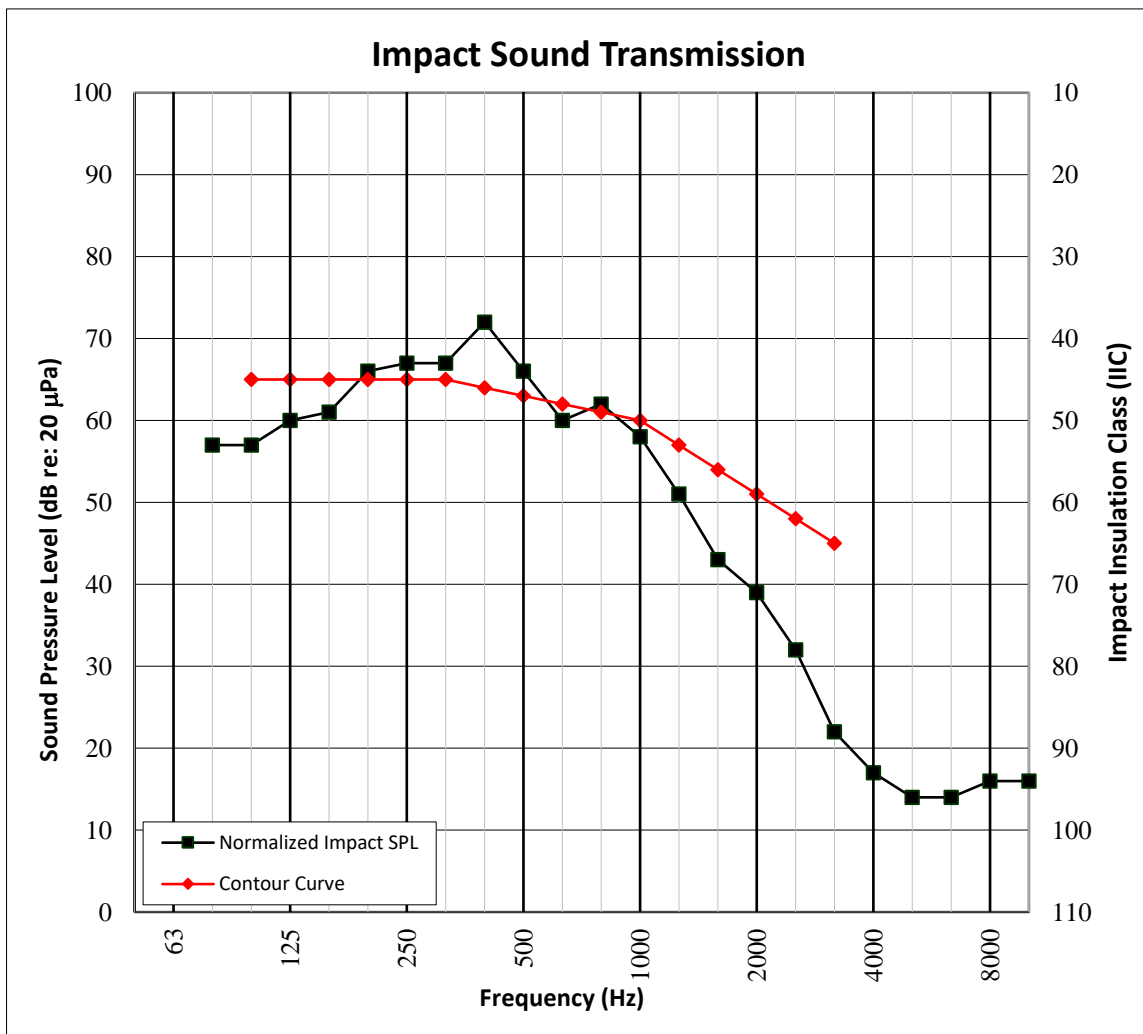
TEST RESULTS - IMPACT SOUND TRANSMISSION GRAPH

TEST DATE	2/18/2018				
DATA FILE NO.	H7787.02				
CLIENT	Vulcraft/Verco Group				
DESCRIPTION	4 mm Derr Flooring Fusion Hybrid Luxury Vinyl Plank, 2 mm ECOsilence Rubber Underlayment, 152.4 mm Standard 4000 PSI Concrete, 152.4 mm 20 Gage Vulcraft Dove Tail 3.50 Steel Deck				
SPECIMEN AREA	10.98 m ²	Maximum Temp.	19.5°C	Minimum Temp.	18.9°C
TECHNICIAN	JPT	Max. Humidity	51%	Min. Humidity	49%

FREQ (Hz)	BACKGROUND SPL (dB)	ABSORPTION m ²	NORMALIZED IMPACT SPL (dB)	95% CONFIDENCE LIMIT	NUMBER OF DEFICIENCIES
80	26.8	16.7	57	1.8	-
100	29.9	15.2	57	0.9	0
125	24.9	10.6	60	1.4	0
160	19.0	10.6	61	0.6	0
200	17.4	10.6	66	0.7	1
250	29.6	11.3	67	0.7	2
315	18.9	10.5	67	0.5	2
400	18.5	9.3	72	0.5	8
500	25.8	8.0	66	0.4	3
630	19.5	8.1	60	0.5	0
800	17.6	7.7	62	0.2	1
1000	18.3	7.4	58	0.3	0
1250	15.4	7.3	51	0.4	0
1600	14.3	7.5	43	0.4	0
2000	10.7	8.4	39	0.5	0
2500	7.5	9.2	32	0.3	0
3150	7.3	10.2	22	0.5	0
4000	8.1	12.2	17	0.5	-
5000	8.9	14.3	14	0.8	-
6300	9.7	18.8	14	0.5	-
8000	10.5	24.7	16	0.4	-
10000	11.4	31.0	16	0.5	-
IIC Rating	47	<i>(Impact Insulation Class)</i>		Sum of Deficiencies	17

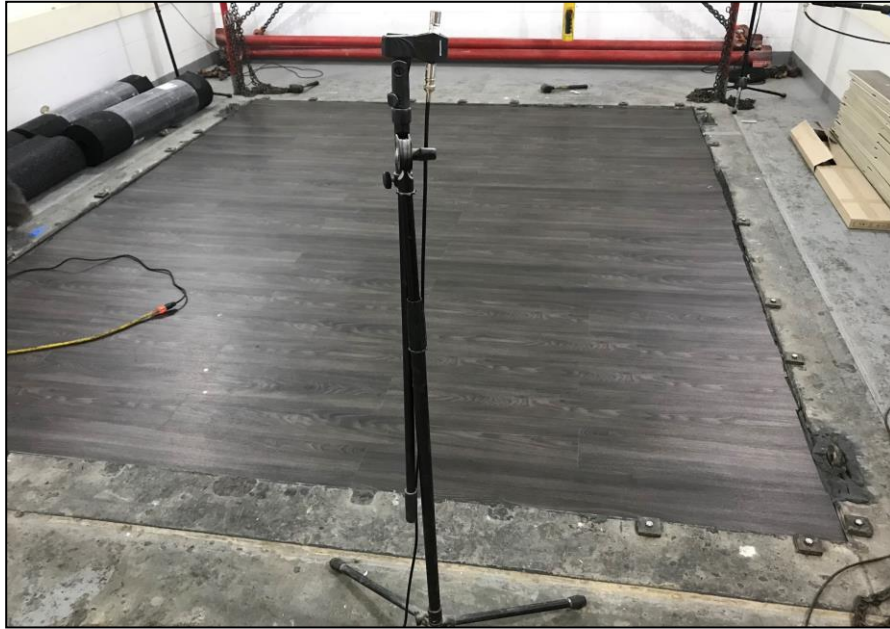
Photo No. 1

Source Room View of Test Specimen Installation

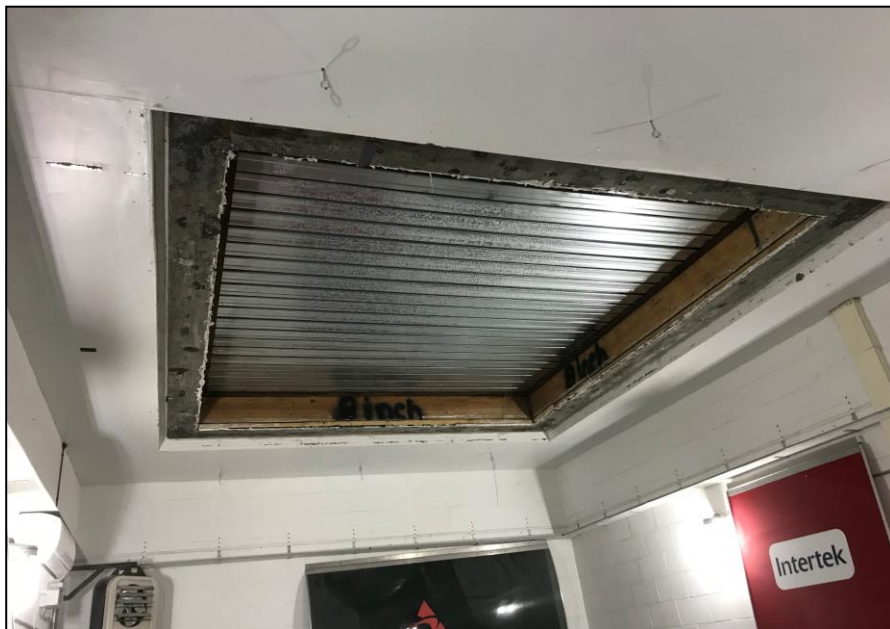
Photo No. 2

Receive Room View of Test Specimen Installation

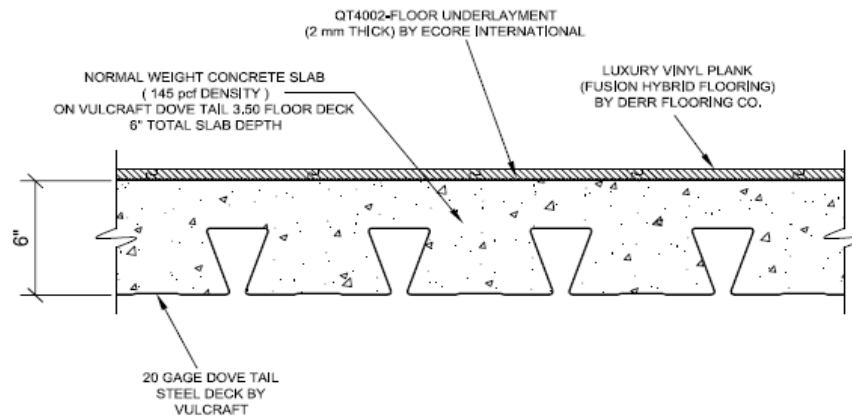
Drawing of Test Specimen (supplied by Client)

MATERIAL	DIMENSIONS (mm/inch)	THICKNESS (mm/inch)	MANUFACTURER AND SERIES	QUANTITY	AVERAGE WEIGHT
Luxury Vinyl Plank	1219 by 177.8	4.0	Derr Flooring Fusion Hybrid	10.98 m ²	6.74 kg/m ²
	Note: Loose laid				
Rubber Underlayment	3023 by 1219	2.0	ECOsilence	10.98 m ²	1.86 kg/m ²
	Note: Loose laid				
Standard 4000 PSI Concrete	3023 by 3632	152.4	N/A	10.98 m ²	270.63 kg/m ²
	Note: Poured directly on the floor deck and allowed to cure for a minimum of 28 days.				
Steel Deck	3023 by 609.6	152.4	20 Gage Vulcraft Dove Tail 3.50	10.98 m ²	12.01 kg/m ²
	Note: Installed per manufacturer's specifications in a test frame with the top of the concrete flush with the source room. All seams and gaps underneath the deck were plugged with backer rod and sealed with Pecora AC-20 Acoustical Sealant.
