# VULCRAFT/VERCO GROUP ACOUSTICAL PERFORMANCE TEST REPORT

ASTM E90 AND ASTM E492 TESTING ON ENGINEERED WOOD OVER 5 MM ECOSILENCE UNDERLAYMENT

Vulcraft 20 Gage Dove Tail 3.50 Steel Deck

H7787.05-113-11-R0

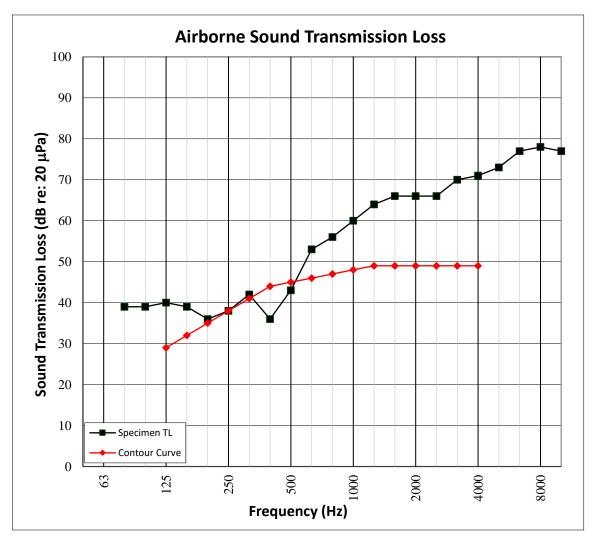
## **TEST RESULTS - AIRBORNE SOUND TRANSMISSION LOSS GRAPH**

TEST DATE	2/18/2018				ACCREDITED	
DATA FILE NO.	H7787.05				Testing	
CLIENT	Vulcraft/Verco	/ulcraft/Verco Group				
DESCRIPTION		2.7 mm Armstrong Engineered Wood, 5 mm ECOsilence Rubber Underlayment, 152.4 nm Standard 4000 PSI Concrete, 152.4 mm 20 Gage Vulcraft Dove Tail 3.50 Steel Deck				
SPECIMEN AREA	10.98 m²	Receive Temp.	19.2°C	Source Temp.	19.5°C	
TECHNICIAN	JPT	Receive Humidity	50%	<b>Source Humidity</b>	50%

BACKGROUND		SOURCE	RECEIVE	SPECIMEN	95%	NUMBER
FREQ	SPL	ABSORPTION	SPL	SPL	TL	CONFIDENCE	OF
(Hz)	(dB)	m²	(dB)	(dB)	(dB)	LIMIT	DEFICIENCIES
80	28.8	16.0	109	69	39	3.4	-
100	35.5	15.0	106	65	39	2.0	-
125	28.9	10.6	105	65	40	1.5	0
160	24.3	10.1	107	69	39	1.0	0
200	17.9	10.7	105	69	36	1.4	0
250	29.4	11.6	104	66	38	1.2	0
315	19.4	10.4	105	64	42	0.9	0
400	18.9	9.2	104	68	36	0.9	8
500	25.5	7.9	103	61	43	0.6	2
630	15.8	7.8	105	53	53	0.4	0
800	16.7	7.6	104	49	56	0.5	0
1000	14.2	7.3	104	46	60	0.4	0
1250	11.8	7.3	104	42	64	0.3	0
1600	10.9	7.5	104	41	66	0.4	0
2000	8.7	8.6	104	39	66	0.5	0
2500	7.1	9.3	102	37	66	0.4	0
3150	7.3	10.3	103	34	70	0.4	0
4000	8.0	12.2	104	32	71	0.5	0
5000	8.9	14.3	103	29	73	0.4	-
6300	9.7	18.6	98	19	77	0.7	-
8000	10.6	24.6	97	15	78	0.7	-
10000	11.4	31.6	92	11	77	0.5	-
STC Ratir	1g 45	(Sound Transmi	ssion Class)		Sum o	of Deficiencies	10

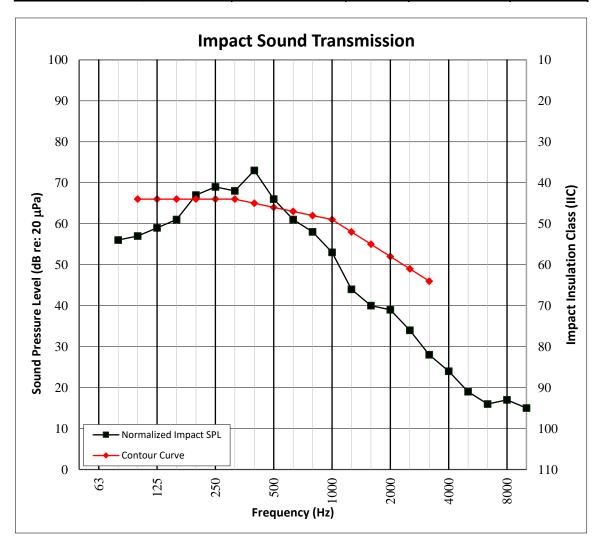
## **TEST RESULTS - IMPACT SOUND TRANSMISSION GRAPH**

TEST DATE DATA FILE NO.	2/18/2018 H7787.05				ACCREDITED Testing	
CLIENT		/ulcraft/Verco Group				
DESCRIPTION		2.7 mm Armstrong Engineered Wood, 5 mm ECOsilence Rubber Underlayment, 152.4 m Standard 4000 PSI Concrete, 152.4 mm 20 Gage Vulcraft Dove Tail 3.50 Steel Deck				
SPECIMEN AREA	10.98 m²	Maximum Temp.	19.5°C	Minimum Temp.	18.9°C	
TECHNICIAN	JPT	Max. Humidity	51%	Min. Humidity	49%

FREQ	BACKGROUND SPL	ABSORPTION	NORMALIZED IMPACT SPL	95% CONFIDENCE	NUMBER OF
(Hz)	(dB)	m²	(dB)	LIMIT	DEFICIENCIES
80	28.1	17.1	56	1.6	-
100	28.9	15.0	57	1.2	0
125	24.7	10.9	59	1.1	0
160	18.9	10.1	61	0.6	0
200	17.7	10.7	67	0.7	1
250	29.7	11.0	69	0.7	3
315	18.9	10.1	68	0.5	2
400	18.7	9.3	73	0.4	8
500	24.7	8.2	66	0.3	2
630	16.0	7.8	61	0.5	0
800	15.3	7.5	58	0.2	0
1000	15.1	7.3	53	0.2	0
1250	11.6	7.3	44	0.3	0
1600	11.3	7.5	40	0.3	0
2000	8.9	8.5	39	0.3	0
2500	7.2	9.2	34	0.3	0
3150	7.2	10.4	28	0.4	0
4000	8.0	12.1	24	0.3	-
5000	8.9	14.3	19	0.4	-
6300	9.7	18.7	16	0.4	-
8000	10.6	24.9	17	0.4	-
10000	11.4	31.2	15	0.5	-
IIC Ratii	<mark>ng</mark> 46	(Impact Insula	tion Class)	Sum of Deficiencies	16

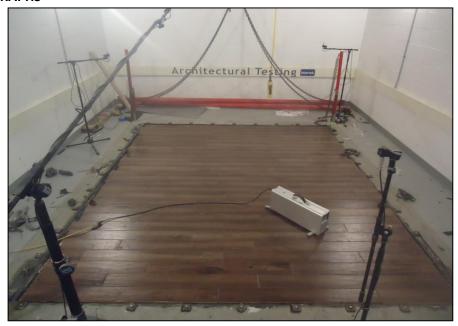
Photo No. 1
Source Room View of Test Specimen Installation

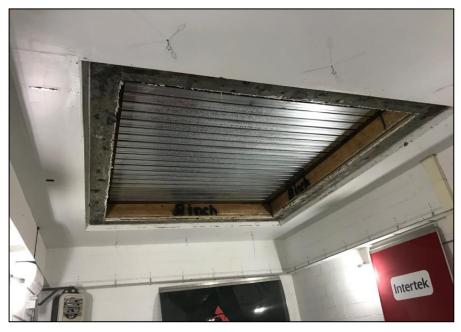
Photo No. 2
Receive Room View of Test Specimen Installation

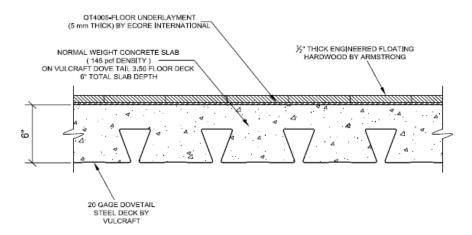
**Drawing of Test Specimen (supplied by Client)**

MATERIAL	DIMENSIONS (mm/inch)	THICKNESS (mm/inch)	MANUFACTURER AND SERIES	QUANTITY	AVERAGE WEIGHT			
Engineered	914.4 by 127	12.7	Armstrong	10.98 m²	6.59 kg/m²			
Wood	Note: Loose laid							
Rubber	3023 by 1219	5.0	ECOsilence	10.98 m²	4.2 kg/m <sup>2</sup>			
Underlayment	Note: Loose laid							
Standard 4000	3023 by 3632	152.4	N/A	10.98 m²	270.63 kg/m²			
PSI Concrete	Note: Poured directly on the floor deck and allowed to cure for a minimum of 28 days.							
	3023 by 609.6	152.4	20 Gage Vulcraft Dove Tail 3.50	10.98 m²	12.01 kg/m²			
Steel Deck  Note: Installed per manufacturer's specifications in a test frame with the top of the con with the source room. All seams and gaps underneath the deck were plugged with back sealed with Pecora AC-20 Acoustical Sealant.
