VULCRAFT/VERCO GROUP ACOUSTICAL PERFORMANCE TEST REPORT

ASTM E90 AND ASTM E492 TESTING ON ATTAIN LVT OVER 5 MM ECOSILENCE UNDERLAYMENT

SPECIMEN TYPE Vulcraft 20 Gage Dove Tail 3.50 Steel Deck with Gypsum Board Ceiling

REPORT NUMBER H7787.09-113-11-R0

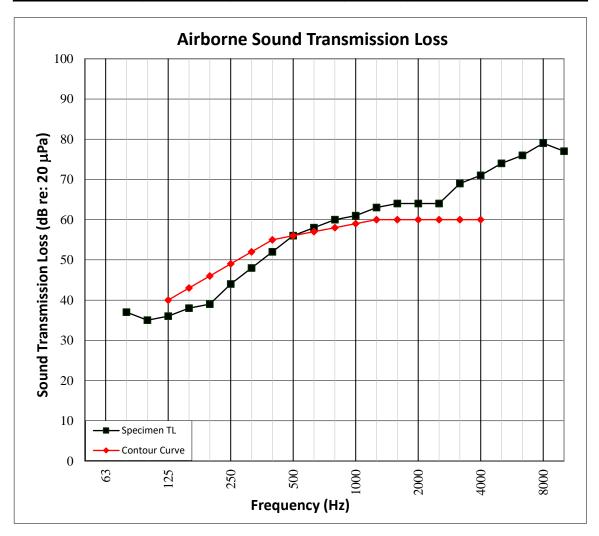
TEST RESULTS - AIRBORNE SOUND TRANSMISSION LOSS GRAPH

TEST DATE	2/17/2018	2/17/2018						
DATA FILE NO.	H7787.09	17787.09						
CLIENT	Vulcraft/Verco	Group			Testing Laboratory			
DESCRIPTION	mm Standard 400 38.1 mm ClarkDie	2.5 mm ECORE Attain Luxury Vinyl Tile, 2 mm ECOsilence Rubber Underlayment, 152.4 nm Standard 4000 PSI Concrete, 152.4 mm 20 Gage Vulcraft Dove Tail 3.50 Steel Deck, 88.1 mm ClarkDietrich 25 Gage Furring Channel, 15.9 mm USG SHEETROCK [®] Brand IRECODE [®] C Core Gypsum Panel						
SPECIMEN AREA	10.98 m²	98 m ² Receive Temp. 18.9°C Source Temp. 18.1						
TECHNICIAN	JPT	Receive Humidity	57%	Source Humidity	57%

5050	BACKGROUND		SOURCE	RECEIVE	SPECIMEN	95%	NUMBER
FREQ	SPL	ABSORPTION	SPL	SPL	TL	CONFIDENCE	OF
(Hz)	(dB)	m²	(dB)	(dB)	(dB)	LIMIT	DEFICIENCIES
80	29.4	17.7	109	70	37	3.0	-
100	28.6	17.3	106	69	35	1.9	-
125	28.3	12.0	105	68	36	1.6	4
160	22.0	11.4	108	70	38	1.0	5
200	21.3	10.8	105	66	39	1.5	7
250	29.3	11.1	105	60	44	1.1	5
315	21.2	10.0	106	58	48	0.7	4
400	20.2	8.7	105	54	52	0.8	3
500	26.3	7.8	104	49	56	0.2	0
630	20.7	7.3	105	48	58	0.3	0
800	20.6	7.3	104	46	60	0.3	0
1000	22.2	7.0	104	46	61	0.4	0
1250	16.7	7.3	104	43	63	0.4	0
1600	14.5	7.7	104	42	64	0.5	0
2000	11.6	8.7	104	41	64	0.4	0
2500	8.9	9.7	102	38	64	0.2	0
3150	7.7	10.9	103	35	69	0.4	0
4000	8.2	12.5	104	32	71	0.3	0
5000	8.9	14.9	104	29	74	0.4	-
6300	9.7	19.1	97	19	76	0.6	-
8000	10.5	25.3	97	14	79	0.7	-
10000	11.4	32.3	92	10	77	0.8	-
STC Rat	ing 56	(Sound Transm	nission Class)	Sum	of Deficiencies	28

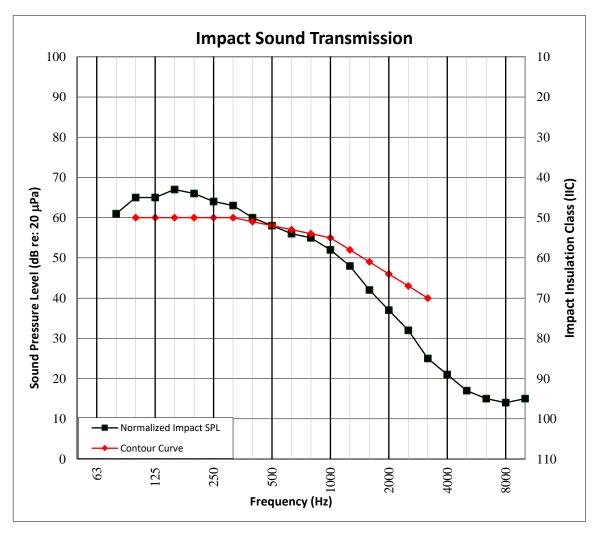
TEST RESULTS - IMPACT SOUND TRANSMISSION GRAPH

DATA FILE NO. CLIENT DESCRIPTION	H7787.09 Testing Laboratory Vulcraft/Verco Group Issue to the state of the st					
	mm Standard 4000 PSI Concrete, 152.4 mm 20 Gage Vulcraft Dove Tail 3.50 Steel Deck, 38.1 mm ClarkDietrich 25 Gage Furring Channel, 15.9 mm USG SHEETROCK® Brand FIRECODE® C Core Gypsum Panel					
SPECIMEN AREA	10.98 m²	Maximum Temp.	18.9°C	Minimum Temp.	18.9°C	
TECHNICIAN	JPT	Max. Humidity	57%	Min. Humidity	56%

FREQ	BACKGROUND SPL	ABSORPTION	NORMALIZED IMPACT SPL	95% CONFIDENCE	NUMBER OF
(Hz)	(dB)	m²	(dB)	LIMIT	DEFICIENCIES
80	30.5	18.4	61	2.5	-
100	33.6	17.1	65	1.6	5
125	31.5	11.5	65	1.3	5
160	32.8	12.0	67	1.1	7
200	24.0	11.8	66	0.4	6
250	29.7	10.9	64	1.0	4
315	24.8	10.1	63	0.4	3
400	21.5	8.5	60	0.4	1
500	26.4	7.7	58	0.3	0
630	21.7	7.4	56	0.4	0
800	21.2	7.2	55	0.4	0
1000	21.8	7.1	52	0.5	0
1250	18.7	7.1	48	0.5	0
1600	15.8	7.6	42	0.4	0
2000	13.2	8.7	37	0.3	0
2500	9.6	9.6	32	0.3	0
3150	7.9	10.8	25	0.4	0
4000	8.1	12.5	21	0.4	-
5000	8.8	14.7	17	0.4	-
6300	9.7	19.2	15	0.5	-
8000	10.5	25.5	14	0.4	-
10000	11.4	32.5	15	0.6	-
IIC Rati	ng 52	(Impact Insula	tion Class)	Sum of Deficiencies	31

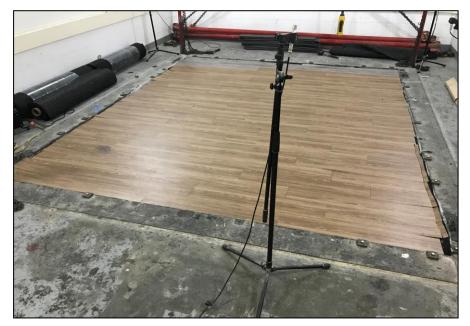
Photo No. 1 Source Room View of Test Specimen Installation

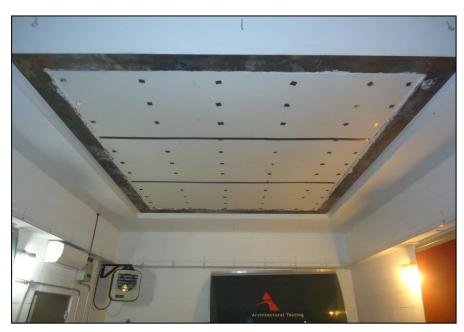
Photo No. 2 Receive Room View of Test Specimen Installation

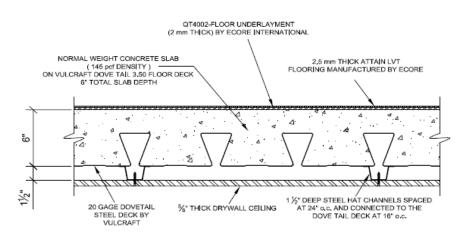
Drawing of Test Specimen (supplied by Client)

MATERIAL	DIMENSIONS (mm/inch)	THICKNESS (mm/inch)	MANUFACTURER AND SERIES	QUANTITY	AVERAGE WEIGHT			
	914.4 by 152.4	2.5	ECORE Attain	10.98 m²	3.37 kg/m²			
Luxury Vinyl Tile		-	with ECORE™ EGrip™ III adh vas allowed to cure per manu	-	-			
	3023 by 1219	2.0	ECOsilence	10.98 m²	1.86 kg/m²			
Rubber Underlayment								
Standard 4000	3023 by 3632	152.4	N/A	10.98 m²	270.63 kg/m²			
PSI Concrete	Note: Poured directly on the floor deck and allowed to cure for a minimum of 28 days.							
	3023 by 609.6	152.4	20 Gage Vulcraft Dove Tail 3.50	10.98 m²	12.01 kg/m²			
Steel Deck	with the source re		pecifications in a test frame d gaps underneath the deck v I Sealant.					
25 Gage Furring	3023 by 63.6	38.1	ClarkDietrich	21.16 lin m	0.98 kg/m			
Channel	Note: The furring channels were attached directly to the bottom of the steel deck, spaced 6 mm on center. The measured steel thickness was 1.2 mm.							
Currente Den si	1219 by 3023	15.9	USG SHEETROCK [®] Brand FIRECODE [®] C Core	10.98 m²	11.91 kg/m²

Gypsum Panel		Note: Fastened with 25.4 mm fine thread drywall screws on 610 mm centers. Seams and perimeter sealed with Pecora AC-20 [®] Acoustical Sealant and covered with pressure-sensitive tape.
