# VULCRAFT/VERCO GROUP ACOUSTICAL PERFORMANCE TEST REPORT

ASTM E90 AND ASTM E492 TESTING ON FOREST RX RUBBER BACK SHEET VINYL

Vulcraft 20 Gage Dove Tail 3.50 Steel Deck with Gypsum Board Ceiling

H7787.10-113-11-R0

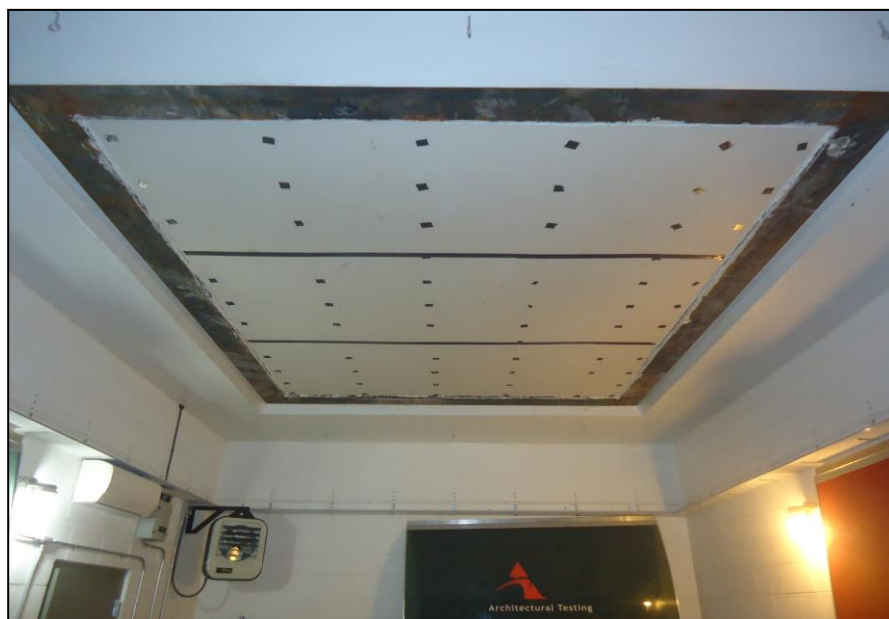
**Photo No. 2**

**Receive Room View of Test Specimen Installation**
