# VULCRAFT/VERCO GROUP ACOUSTICAL PERFORMANCE TEST REPORT

ASTM E90 AND ASTM E492 TESTING ON  
CERAMIC TILE ON 5 MM ECOSILENCE UNDERLAYMENT

Vulcraft 20 Gage Dove Tail 3.50 Steel Deck with Gypsum Board Ceiling

H7787.12-113-11-R0

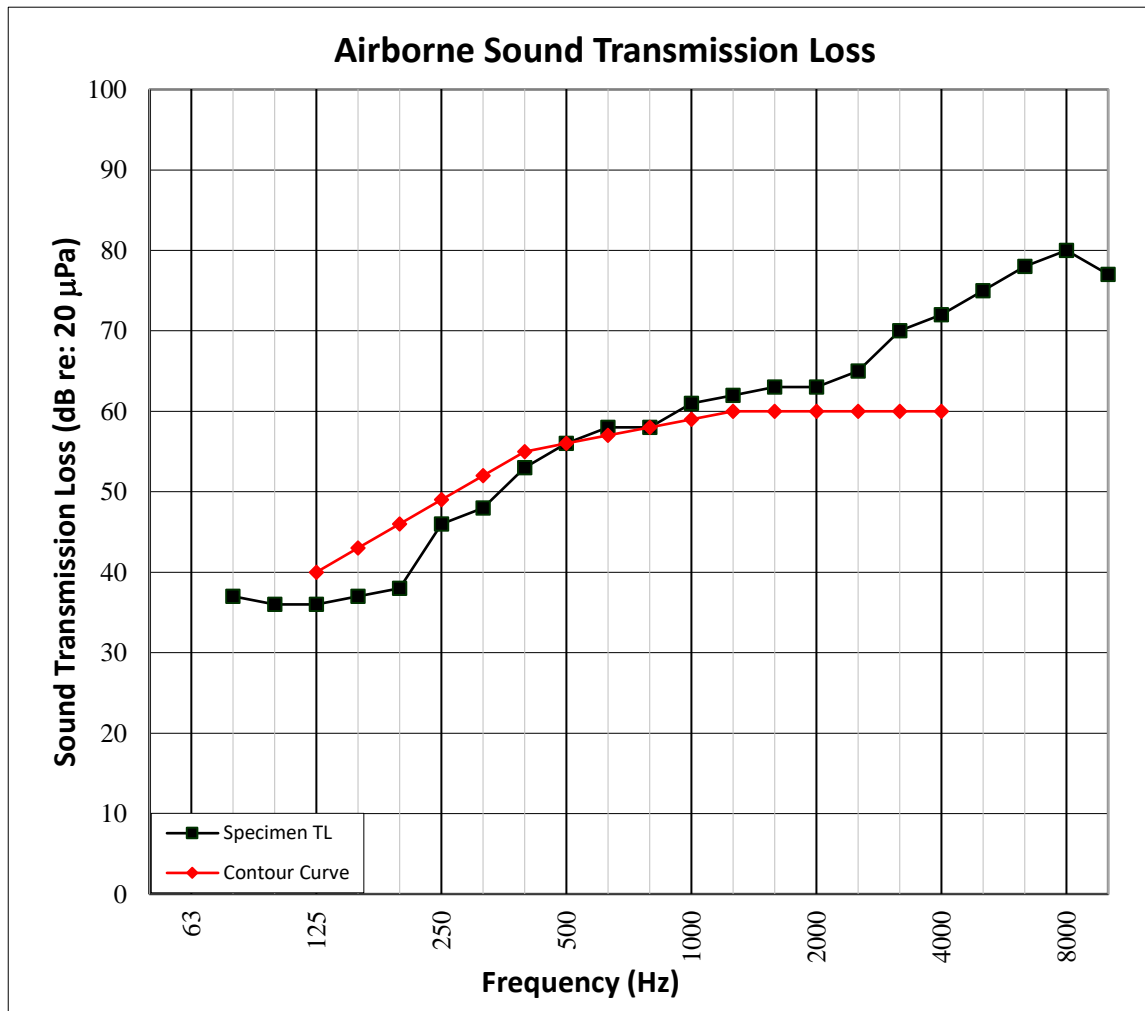
**TEST RESULTS - AIRBORNE SOUND TRANSMISSION LOSS GRAPH**

<b>TEST DATE</b>	2/17/2018				
<b>DATA FILE NO.</b>	H7787.12				
<b>CLIENT</b>	Vulcraft/Verco Group				
<b>DESCRIPTION</b>	8.5 mm Daltile Ceramic Tile, 5 mm ECOSilence Rubber Underlayment, 152.4 mm Standard 4000 PSI Concrete, 152.4 mm 20 Gage Vulcraft Dove Tail 3.50 Steel Deck, 38.1 mm ClarkDietrich 25 Gage Furring Channel, 15.9 mm USG SHEETROCK® Brand FIRECODE® C Core Gypsum Panel				
<b>SPECIMEN AREA</b>	10.98 m <sup>2</sup>	<b>Receive Temp.</b>	18.9°C	<b>Source Temp.</b>	19°C
<b>TECHNICIAN</b>	JPT	<b>Receive Humidity</b>	57%	<b>Source Humidity</b>	57%

FREQ (Hz)	BACKGROUND SPL (dB)	ABSORPTION m <sup>2</sup>	SOURCE SPL (dB)	RECEIVE SPL (dB)	SPECIMEN TL (dB)	95% CONFIDENCE LIMIT	NUMBER OF DEFICIENCIES
80	30.1	17.7	110	71	37	3.2	-
100	27.5	17.3	105	68	36	1.8	-
125	26.1	11.6	105	69	36	1.6	4
160	22.8	11.6	107	69	37	0.8	6
200	23.2	10.3	105	67	38	1.4	8
250	32.7	11.5	104	59	46	0.9	3
315	18.7	10.4	106	58	48	0.8	4
400	20.4	8.9	105	53	53	0.4	2
500	21.3	7.8	103	49	56	0.3	0
630	16.7	7.4	105	49	58	0.4	0
800	18.1	7.4	104	47	58	0.6	0
1000	16.5	7.2	104	46	61	0.3	0
1250	14.6	7.2	104	44	62	0.3	0
1600	15.2	7.6	104	42	63	0.5	0
2000	15.6	8.4	104	42	63	0.5	0
2500	14.7	9.4	102	38	65	0.5	0
3150	13.3	10.6	104	34	70	0.5	0
4000	12.0	12.1	104	32	72	0.4	0
5000	11.0	13.9	104	28	75	0.4	-
6300	11.0	18.0	98	18	78	0.5	-
8000	11.6	23.6	97	14	80	0.6	-
10000	12.2	30.5	92	11	77	0.7	-
<b>STC Rating</b>	<b>56</b>	<i>(Sound Transmission Class)</i>			<b>Sum of Deficiencies</b>	<b>27</b>

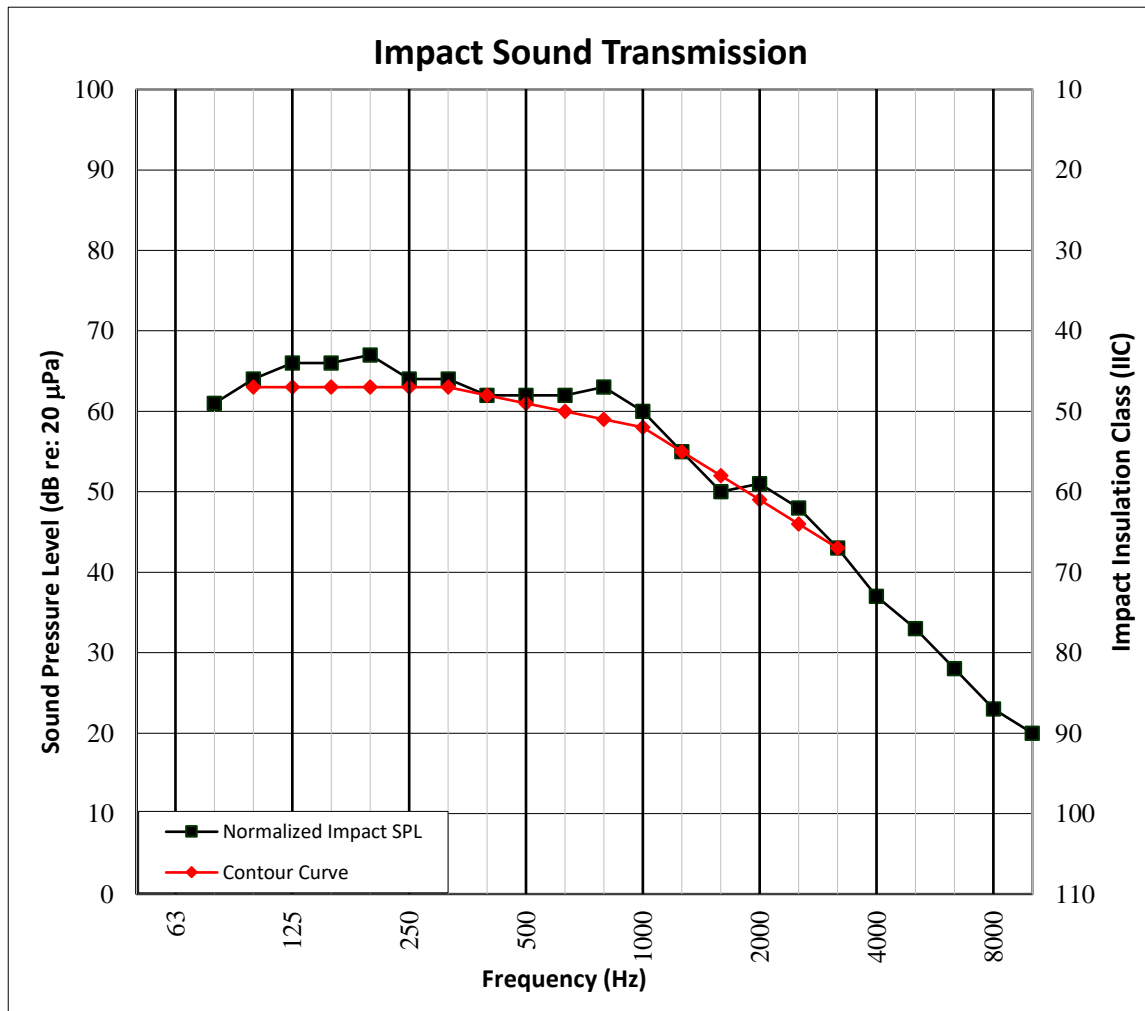
**TEST RESULTS - IMPACT SOUND TRANSMISSION GRAPH**

<b>TEST DATE</b>	2/17/2018				
<b>DATA FILE NO.</b>	H7787.12				
<b>CLIENT</b>	Vulcraft/Verco Group				
<b>DESCRIPTION</b>	8.5 mm Daltile Ceramic Tile, 5 mm ECOSilence Rubber Underlayment, 152.4 mm Standard 4000 PSI Concrete, 152.4 mm 20 Gage Vulcraft Dove Tail 3.50 Steel Deck, 38.1 mm ClarkDietrich 25 Gage Furring Channel, 15.9 mm USG SHEETROCK® Brand FIRECODE® C Core Gypsum Panel				
<b>SPECIMEN AREA</b>	10.98 m <sup>2</sup>	<b>Maximum Temp.</b>	18.9°C	<b>Minimum Temp.</b>	18.9°C
<b>TECHNICIAN</b>	JPT	<b>Max. Humidity</b>	57%	<b>Min. Humidity</b>	56%

FREQ (Hz)	BACKGROUND SPL (dB)	ABSORPTION m <sup>2</sup>	NORMALIZED IMPACT SPL (dB)	95% CONFIDENCE LIMIT	NUMBER OF DEFICIENCIES
80	27.3	17.5	61	2.5	-
100	26.2	17.5	64	1.3	1
125	25.4	11.8	66	1.0	3
160	22.1	12.0	66	0.9	3
200	22.8	10.6	67	0.7	4
250	32.9	11.5	64	0.7	1
315	18.2	10.7	64	0.5	1
400	20.3	8.6	62	0.4	0
500	21.1	7.8	62	0.2	1
630	18.2	7.7	62	0.4	2
800	18.8	7.2	63	0.4	4
1000	16.1	7.2	60	0.4	2
1250	13.9	7.2	55	0.5	0
1600	12.8	7.6	50	0.2	0
2000	11.0	8.5	51	0.4	2
2500	11.8	9.4	48	0.3	2
3150	11.9	10.6	43	0.2	0
4000	10.9	12.1	37	0.2	-
5000	10.9	14.0	33	0.4	-
6300	11.4	18.2	28	0.5	-
8000	12.3	23.8	23	0.8	-
10000	12.5	30.2	20	0.9	-
<b>IIC Rating</b>	<b>49</b>	<i>(Impact Insulation Class)</i>		<b>Sum of Deficiencies</b>	<b>26</b>

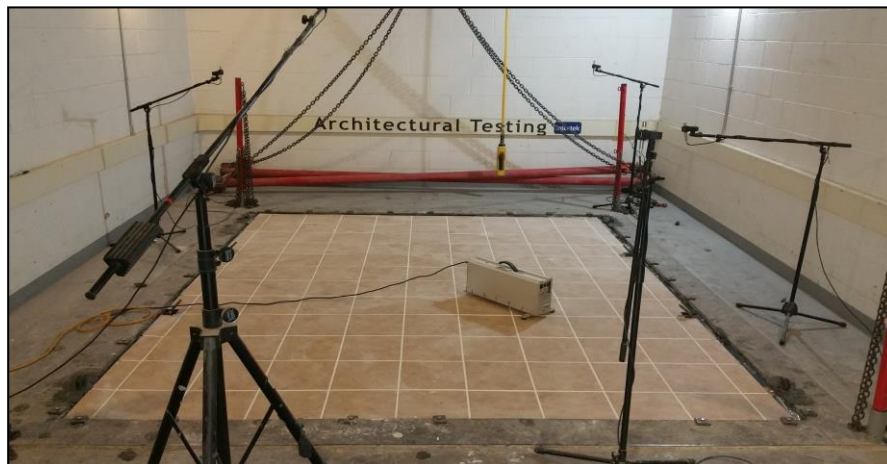
**Photo No. 1**

**Source Room View of Test Specimen Installation**

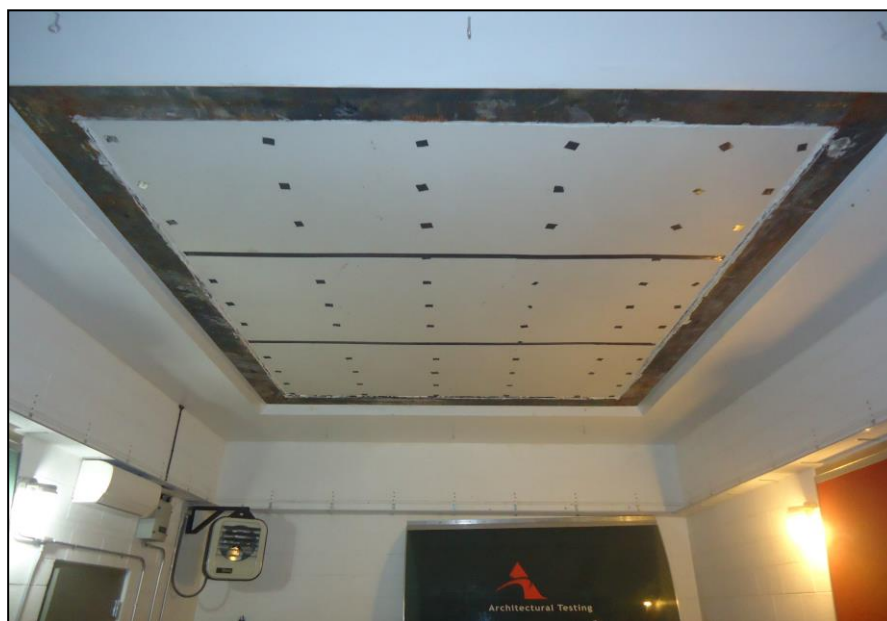
**Photo No. 2**

**Receive Room View of Test Specimen Installation**

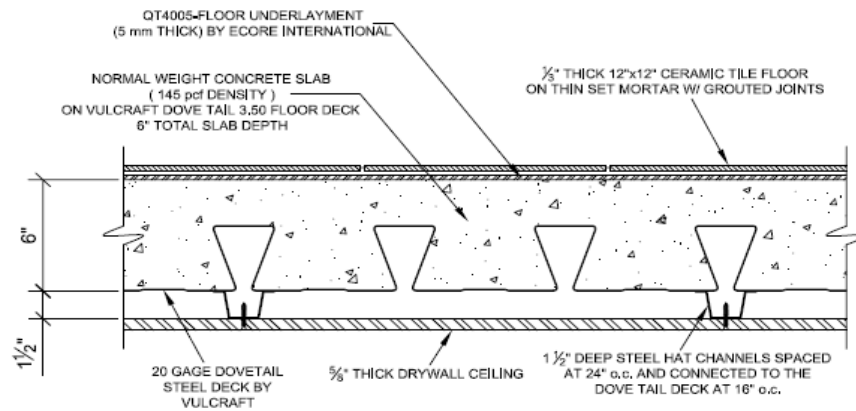
**Drawing of Test Specimen (supplied by Client)**

MATERIAL	DIMENSIONS (mm/inch)	THICKNESS (mm/inch)	MANUFACTURER AND SERIES	QUANTITY	AVERAGE WEIGHT
Ceramic Tile	304.8 by 304.8	8.5	Daltile	10.98 m <sup>2</sup>	15.72 kg/m <sup>2</sup>
	Note: Laticrete Permacolor grout was placed into the 6.35 mm joints between the porcelain tile and wiped clean. The ceramic tile was placed with light pressure onto a bed of Laticrete Platinum 254 mortar on the underlayment. The mortar was set using a 6.35 mm by 6.35 mm trowel. Both the grout and mortar were allowed to cure to manufacturer's specifications.				
Rubber Underlayment	3023 by 1219	5.0	ECOsilence	10.98 m <sup>2</sup>	4.2 kg/m <sup>2</sup>
	Note: A sheet of 2 mil polyethylene plastic was adhered to the floor slab with 3M Super 77 spray adhesive. The underlayment was adhered to the sheeting with ECORE™ EGrip™ III adhesive, which was spread using a 0.79 mm by 1.59 mm by 0.79 mm trowel. Adhesive was allowed to cure per manufacturer's specifications.

Standard 4000 PSI Concrete	3023 by 3632	152.4	N/A	10.98 m <sup>2</sup>	270.63 kg/m <sup>2</sup>
	Note: Poured directly on the floor deck and allowed to cure for a minimum of 28 days.				
Steel Deck	3023 by 609.6	152.4	20 Gage Vulcraft Dove Tail 3.50	10.98 m <sup>2</sup>	12.01 kg/m <sup>2</sup>
	Note: Installed per manufacturer's specifications in a test frame with the top of the concrete flush with the source room. All seams and gaps underneath the deck were plugged with backer rod and sealed with Pecora AC-20 Acoustical Sealant.				
25 Gage Furring Channel	3023 by 63.6	38.1	ClarkDietrich	21.16 lin m	0.98 kg/m
	Note: The furring channels were attached directly to the bottom of the steel deck, spaced 610 mm on center. The measured steel thickness was 1.2 mm.				
Gypsum Panel	1219 by 3023	15.9	USG SHEETROCK® Brand FIRECODE® C Core	10.98 m <sup>2</sup>	11.91 kg/m <sup>2</sup>
	Note: Fastened with 25.4 mm fine thread drywall screws on 610 mm centers. Seams and perimeter sealed with Pecora AC-20® Acoustical Sealant and covered with pressure-sensitive tape.
